NASA TN D-1866

DESCRIPTION AND PERFORMANCE OF THREE TRAILBLAZER II REENTRY RESEARCH VEHICLES

*by Reginald R. Lundstrom, Allen B. Henning,
and W. Ray Hook*

*Langley Research Center
Langley Station, Hampton, Va.*

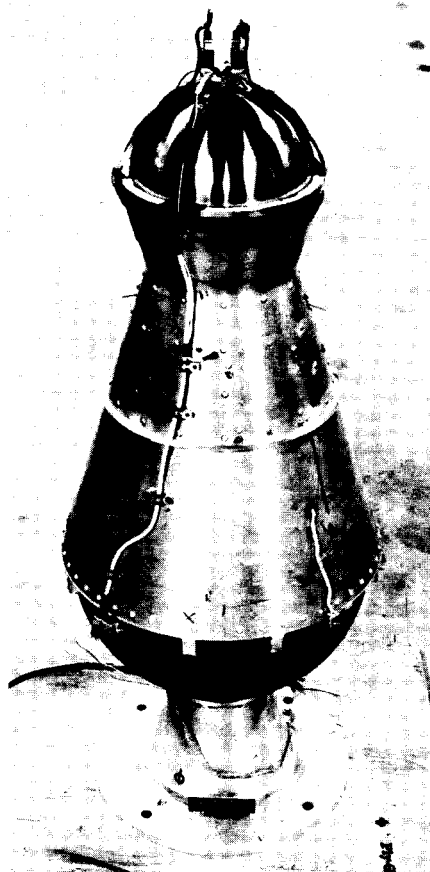
Figure 5.- Photographs of the reentry configurations.

Payloads.- The payloads used in these three vehicles are shown in figures 4 and 5. The payload of Trailblazer IIa (fig. 4(a)), which weighed 45.3 pounds,
